# Situation Photo Log

Friday, June 15, 2012

Kalamazoo River / Enbridge Spill

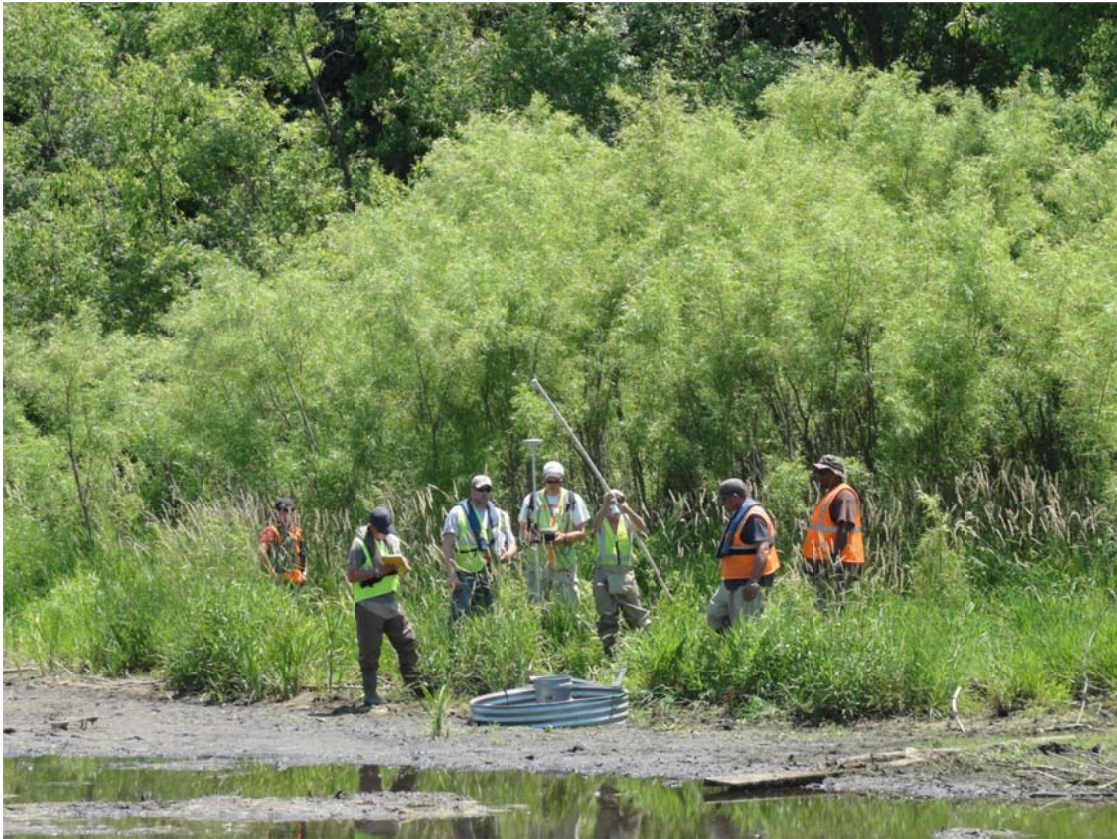
1. Poling crews setting up a ring test near MP 4.5 LDB Lily Pad area.

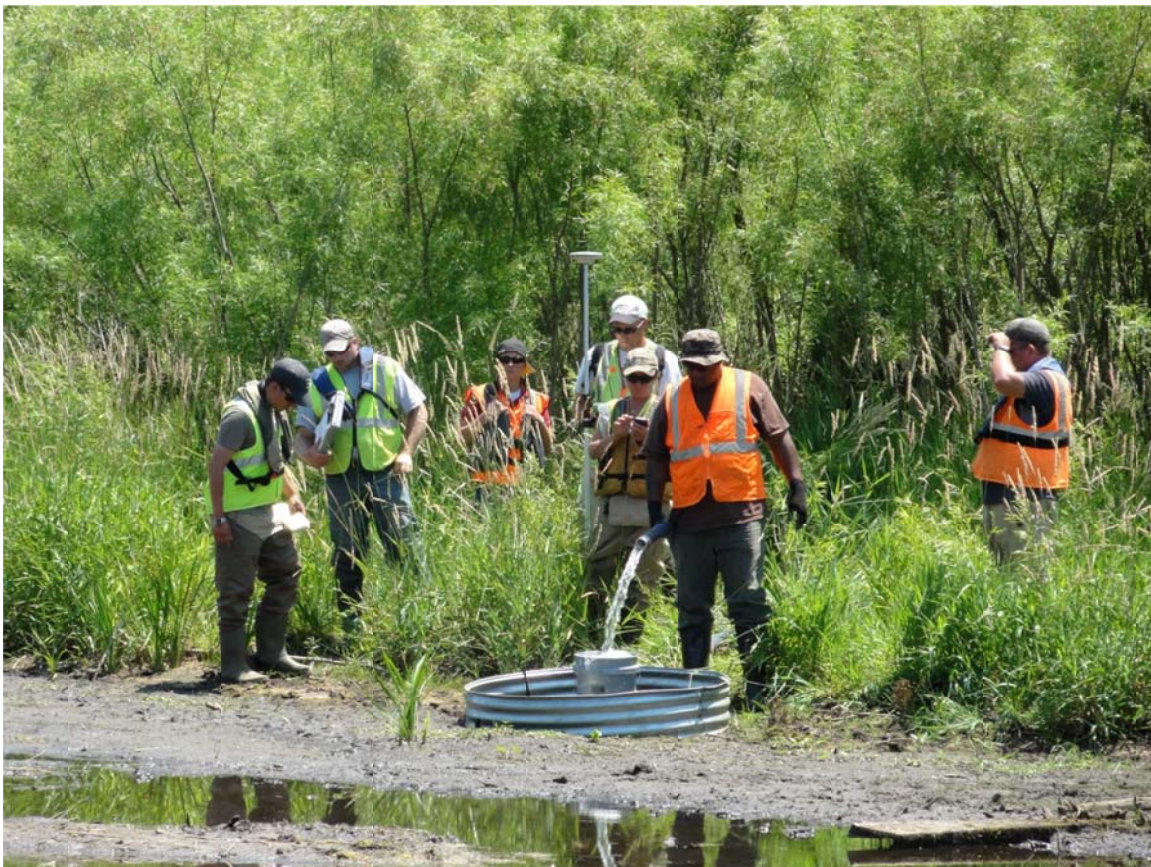
2. Crews filling ring with water for poling test.

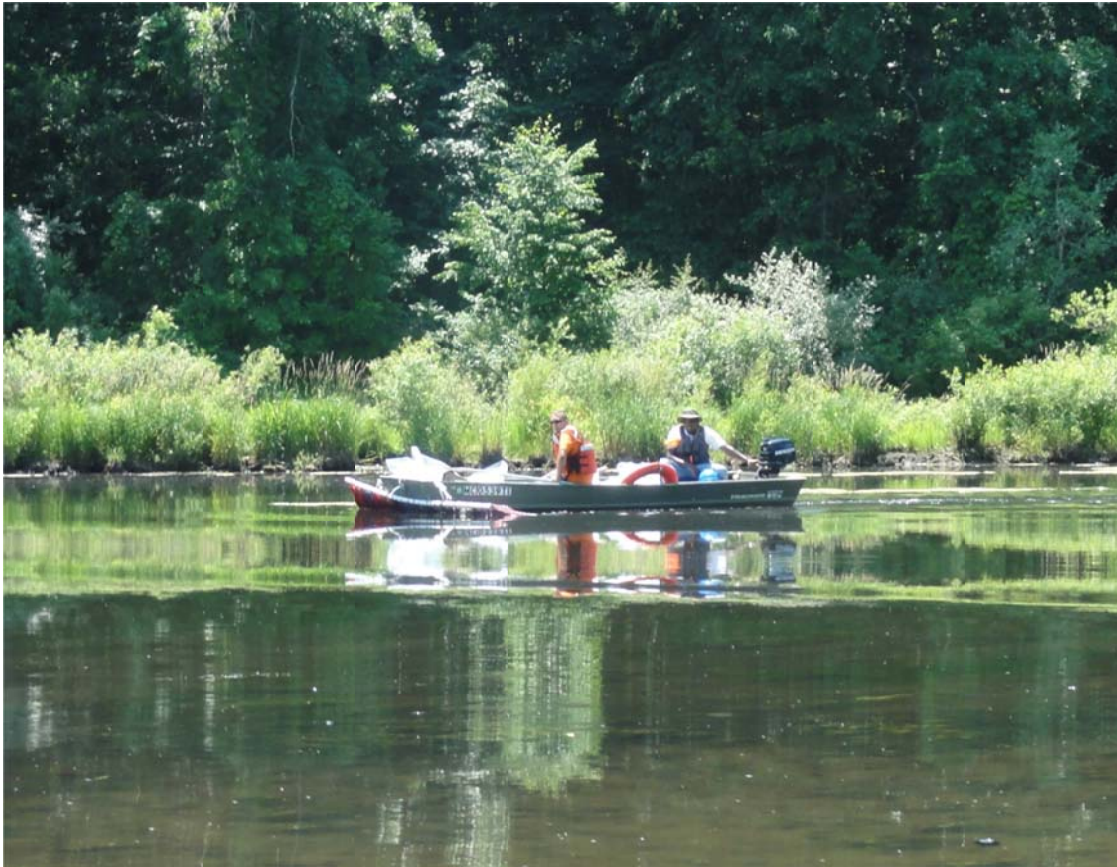
3. Sheen sweep boat operating across the river from C0.4 boat launch.

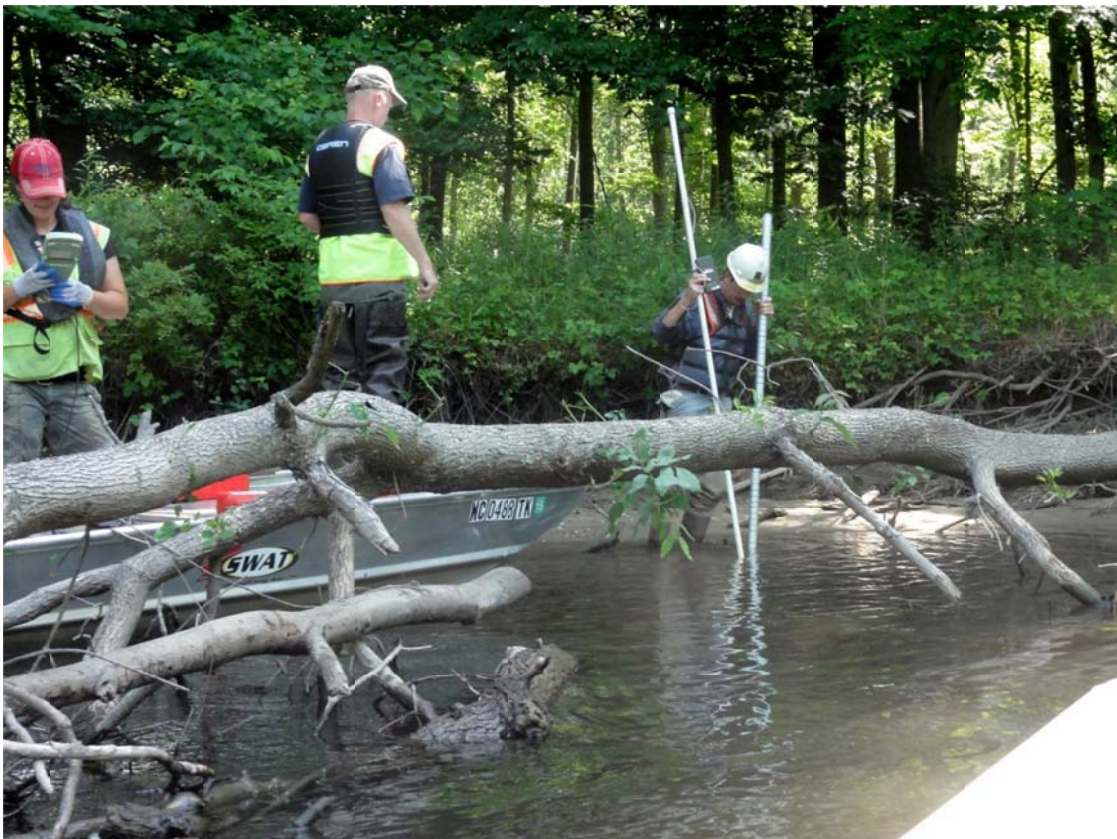
4. Poling crews surveying at MP 25.65 RDB.

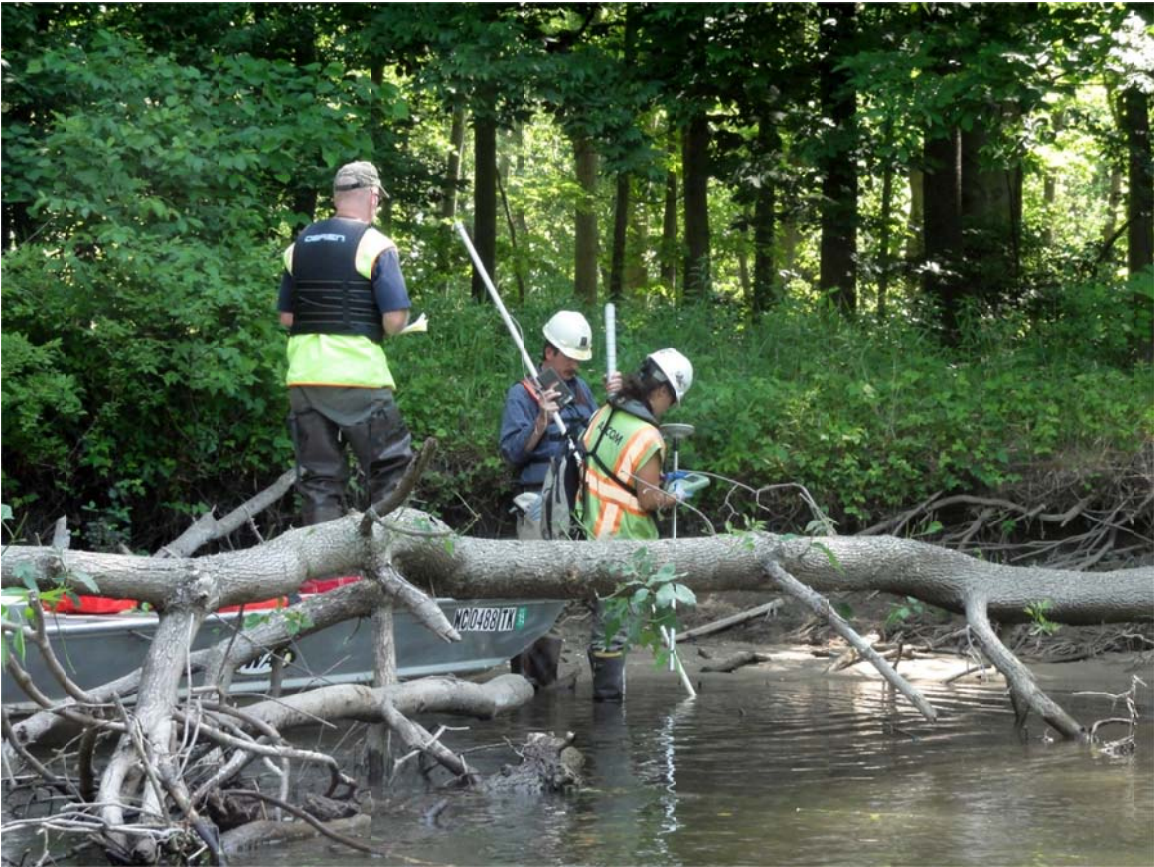
5. Poling crews measuring water and sediment temperature at MP 26.65 LDB.

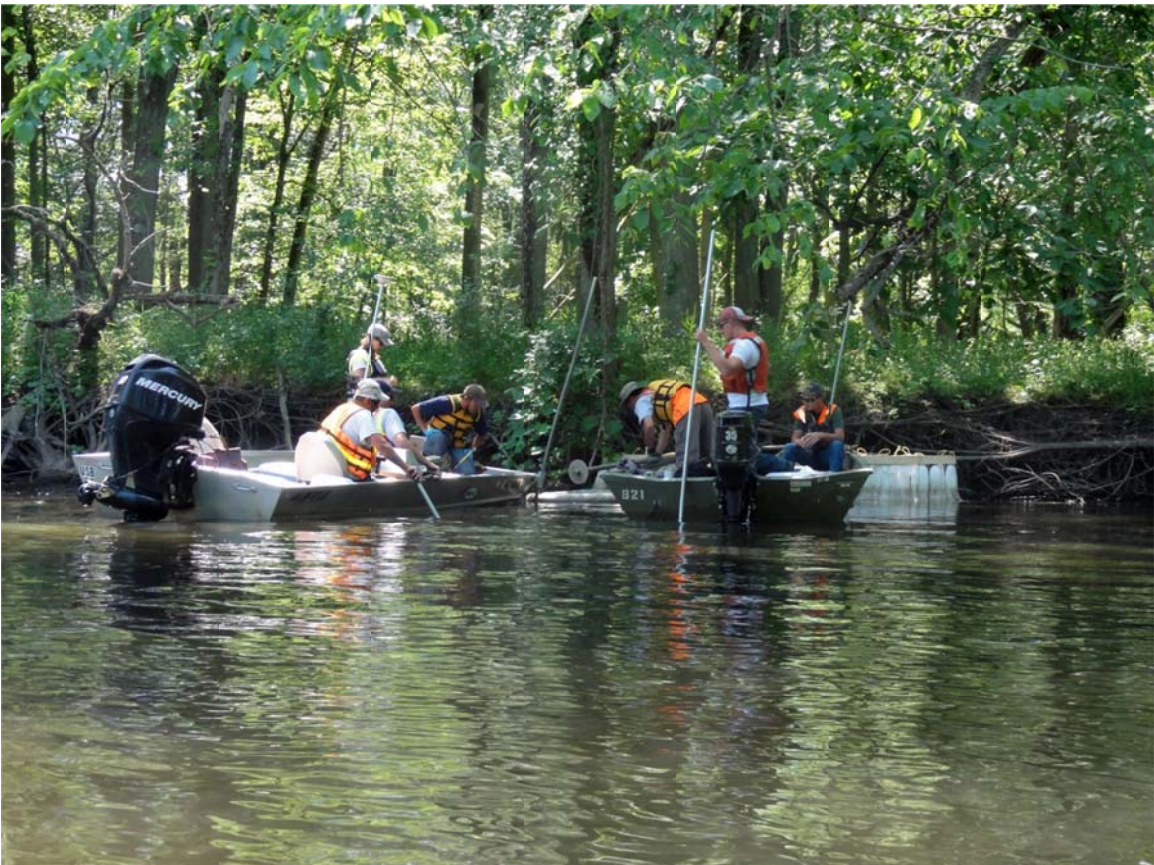
6. Poling crews working near MP 27.5 LDB.

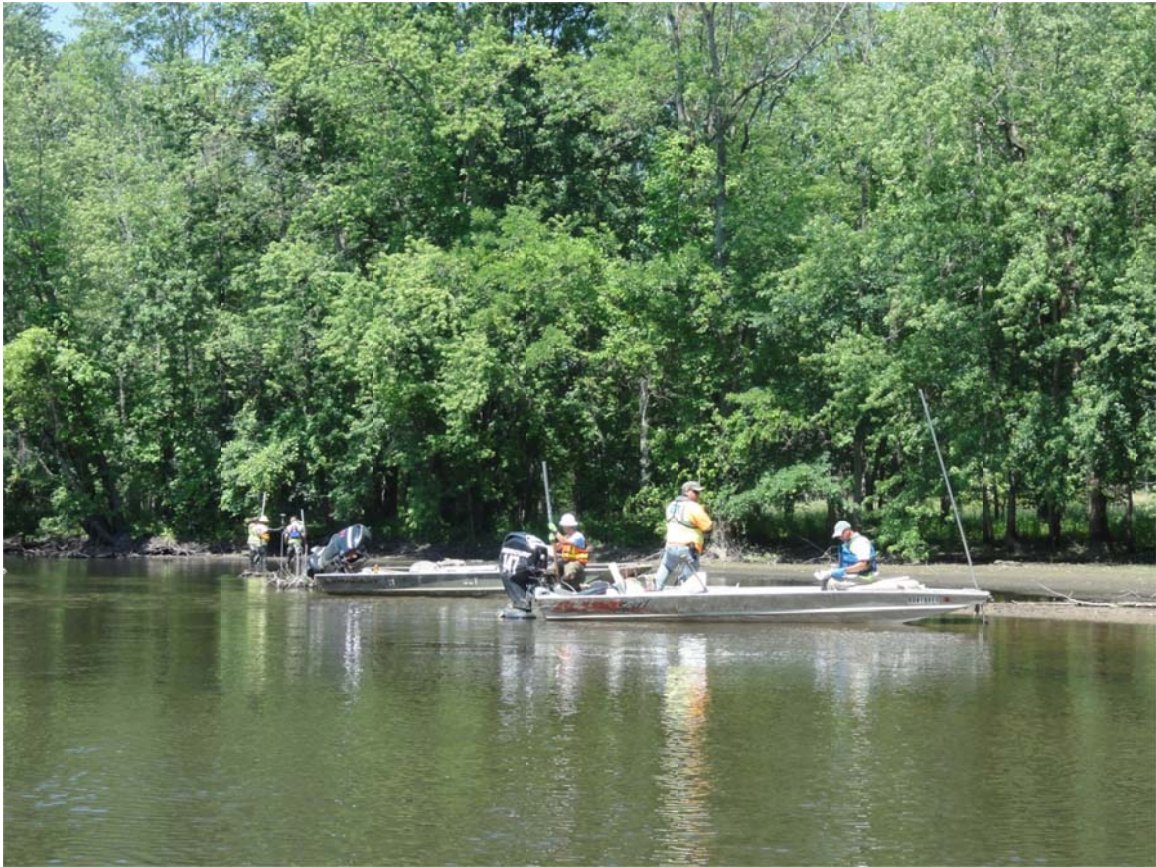
7. Poling crew working near MP 27.5 RDB.

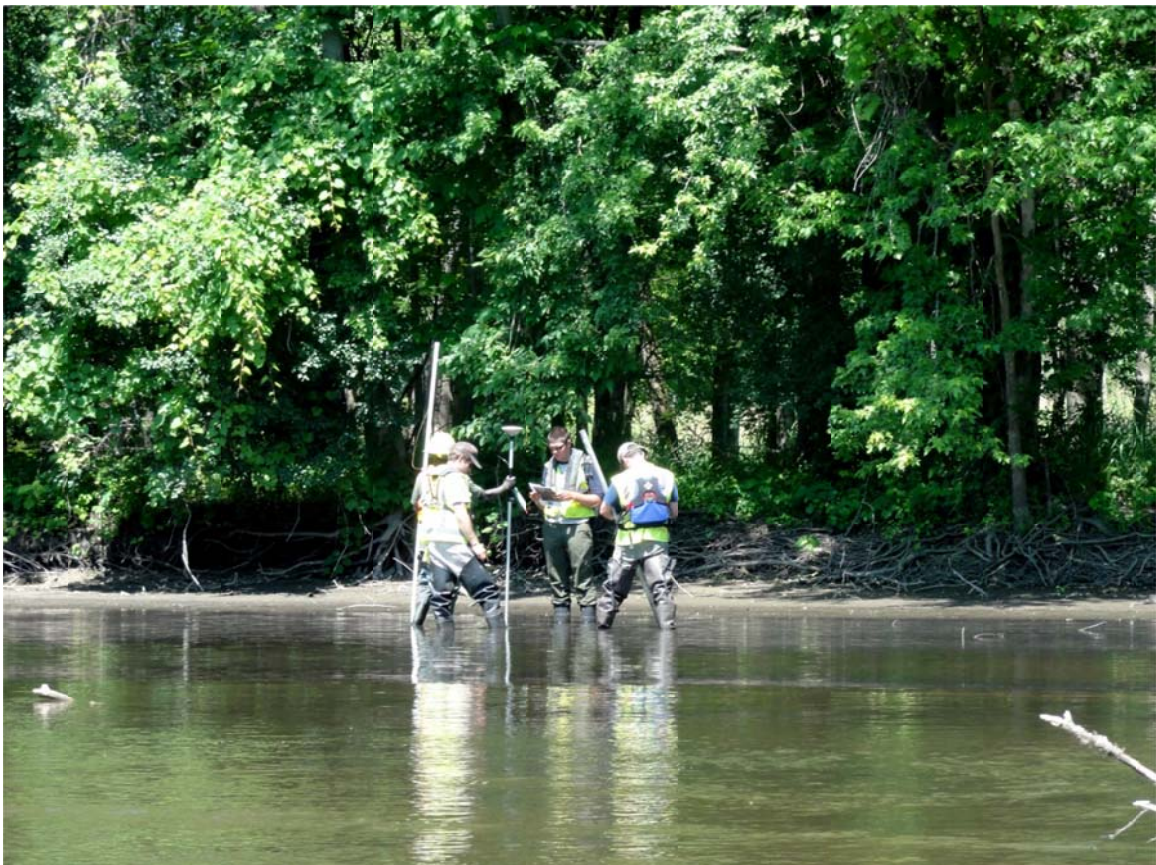
8. Poling crew in shallow river at MP 27.5 RDB.

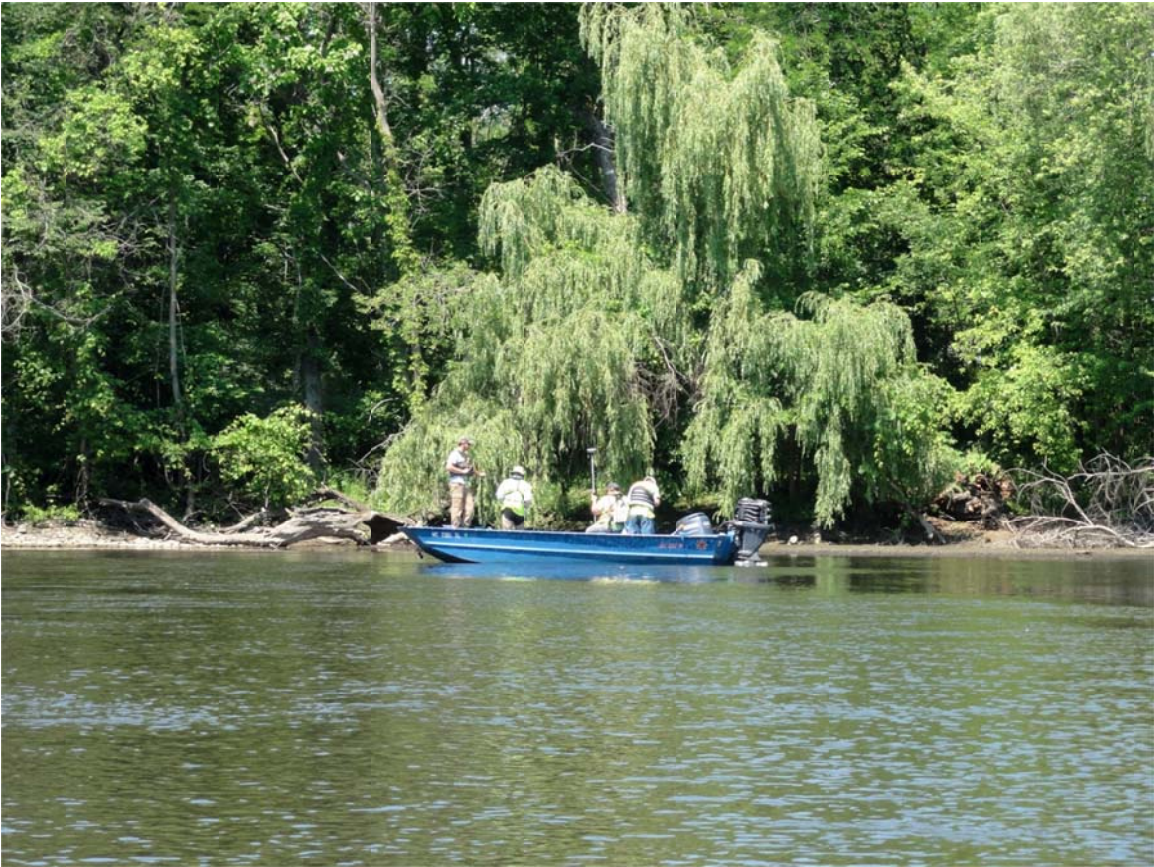
9. Poling crew operating near MP 26.25 RDB.

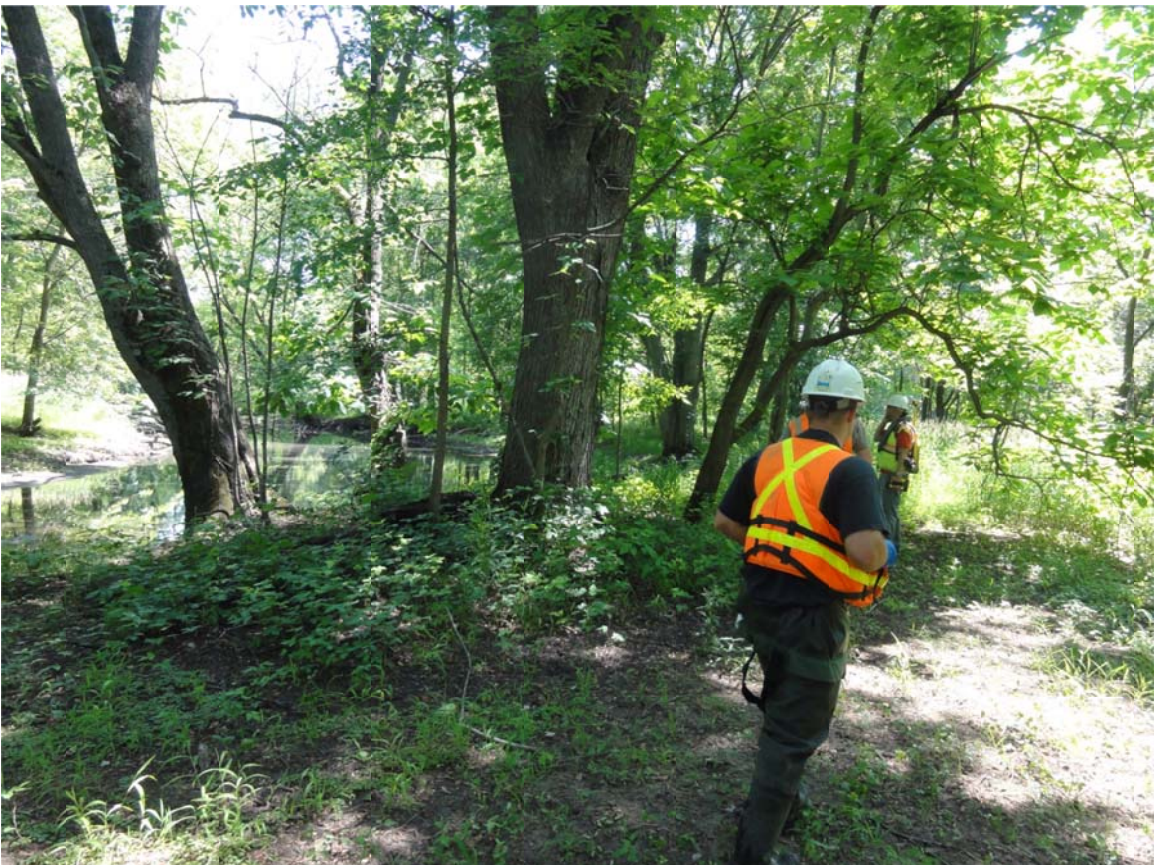
10. Poling crews setting up in overbank channel at MP 26.25 RDB.

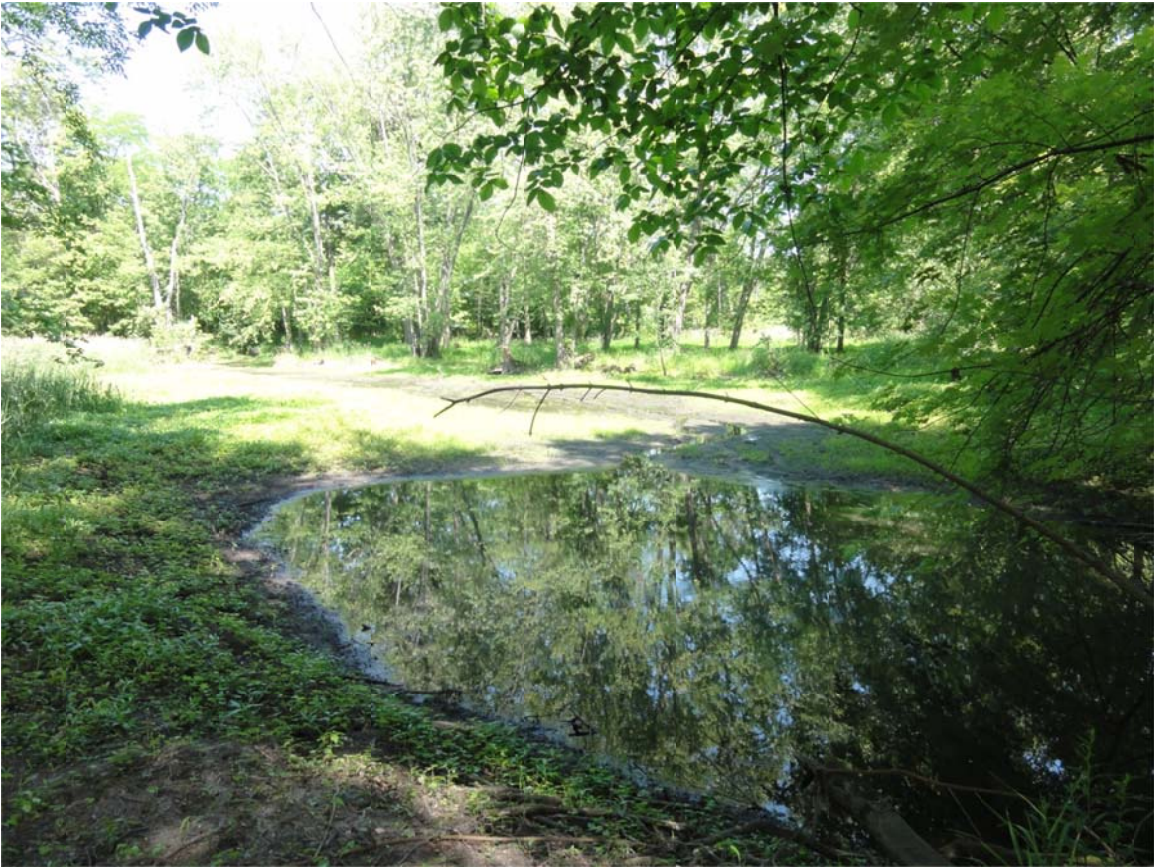
11. MP 26.25 RDB overbank channel. Crews reported heavy sheen at poling points in this channel.

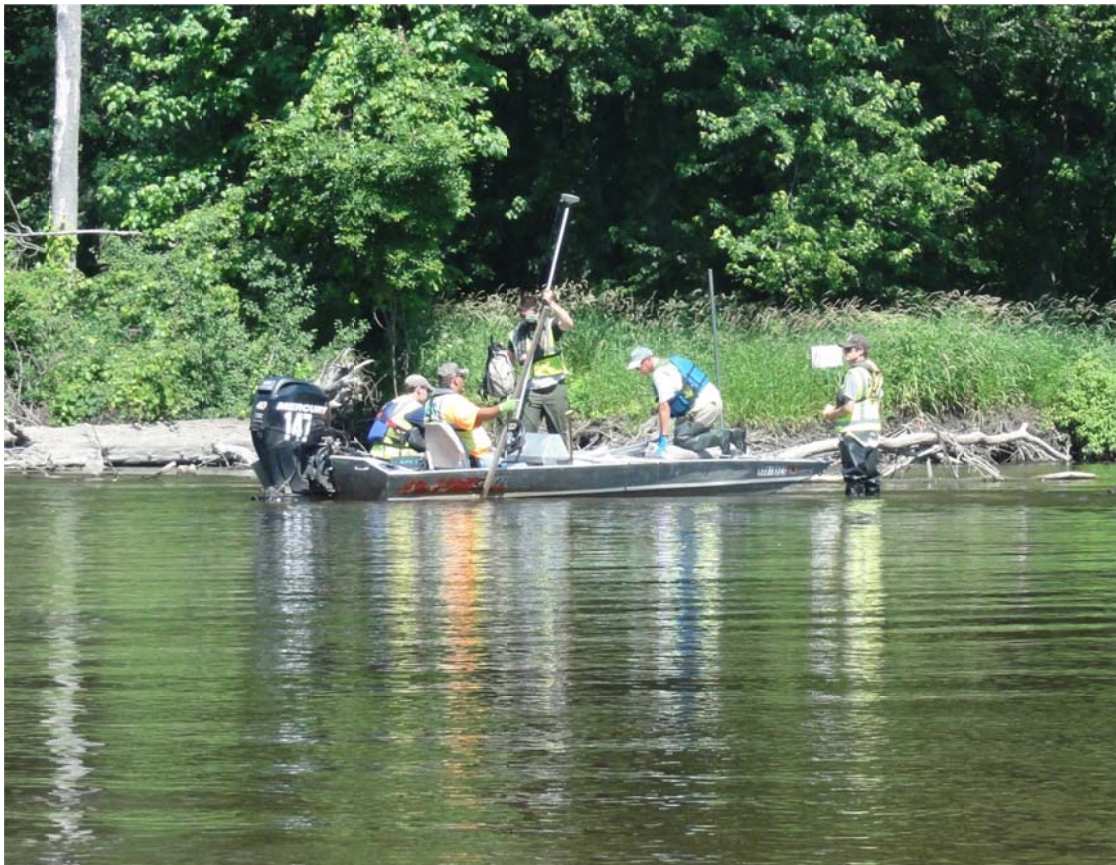
12. Poling crews near MP 27.5.

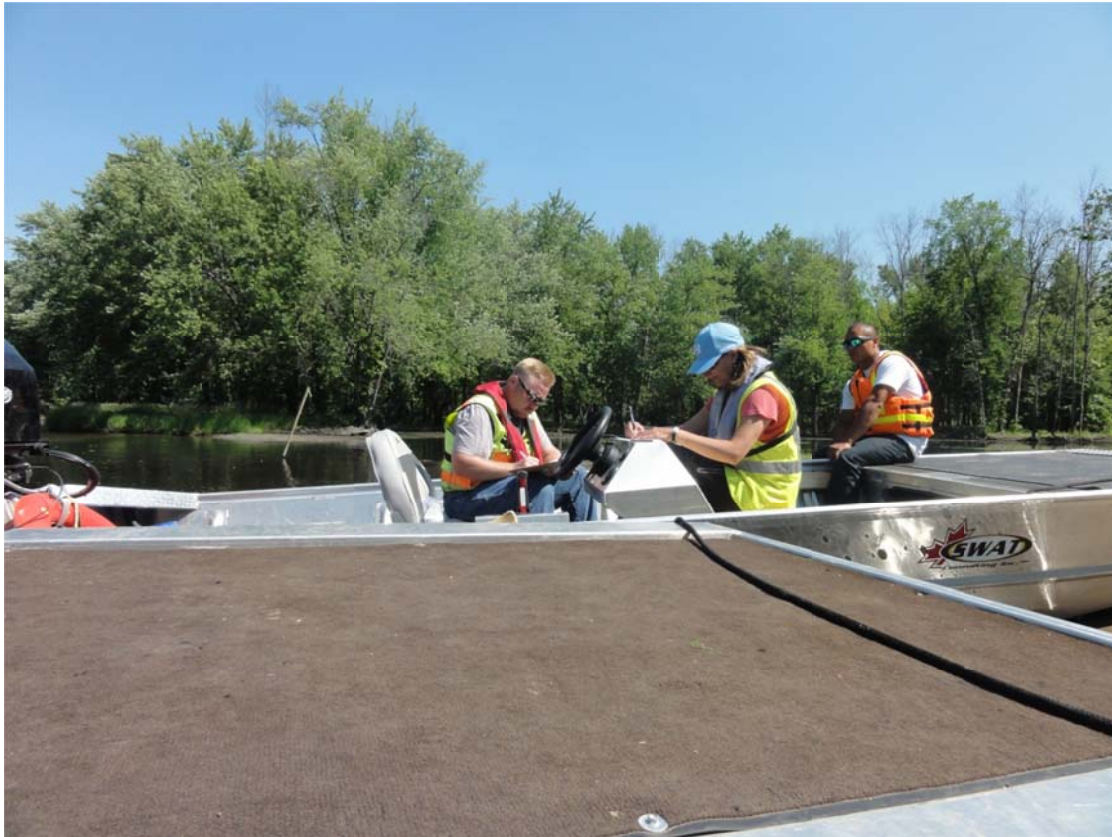
**13. Environmental inspectors conducting sheen test at MP 30.8 LDB. Results of sheen test indicated biogenic sheen.**

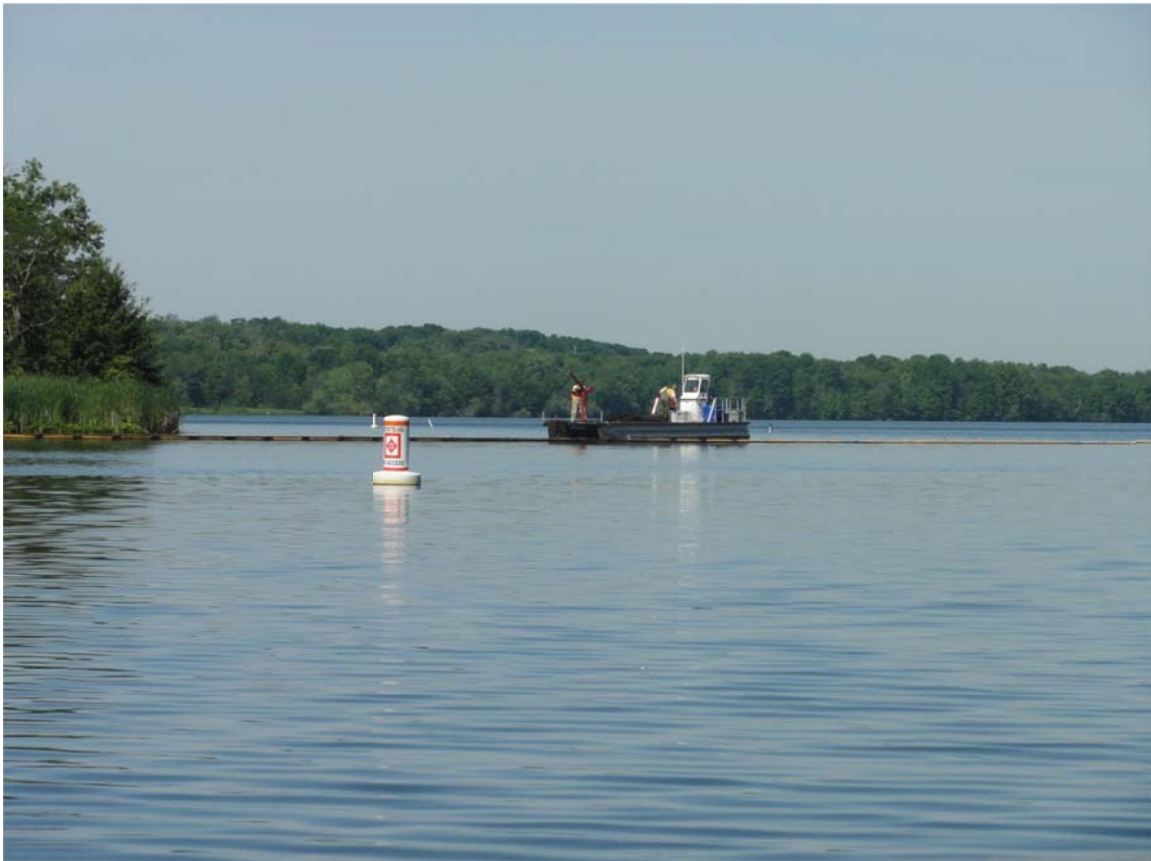
**14. Crews pulling sediment curtain from E 4.0 Control Point.**

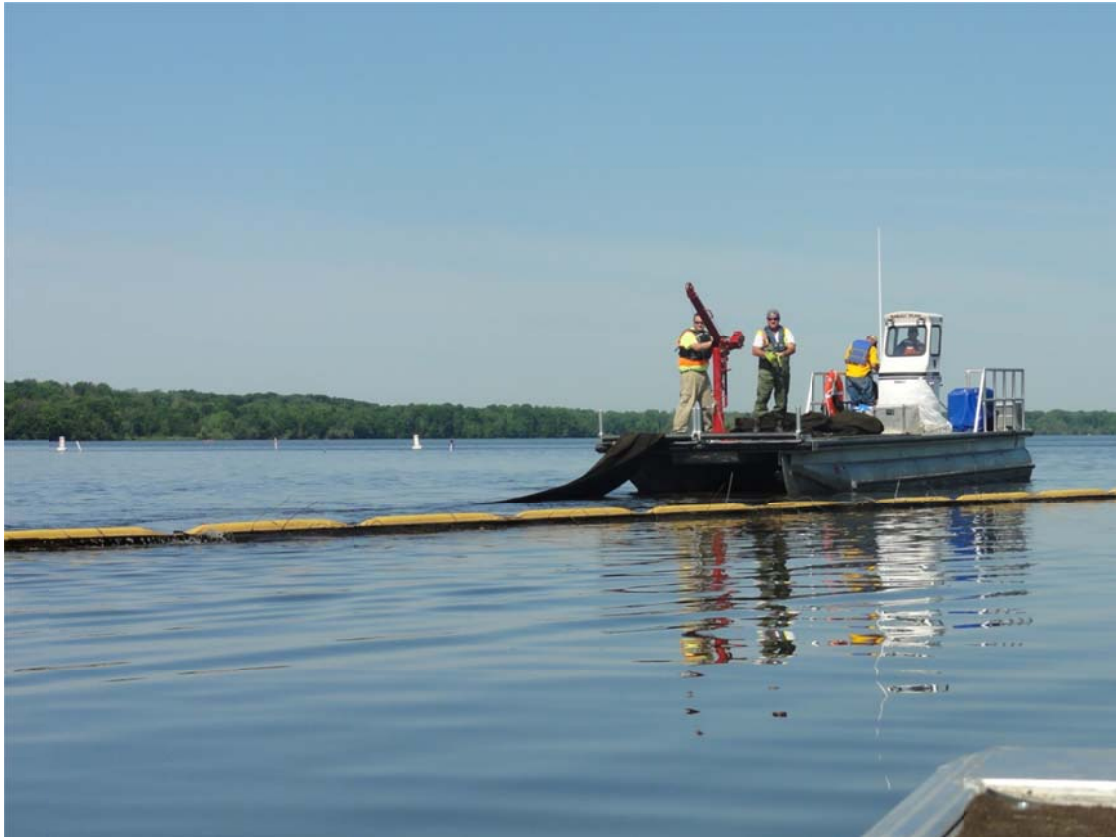
**15. Curtain removal at E4.0 Control Point.**

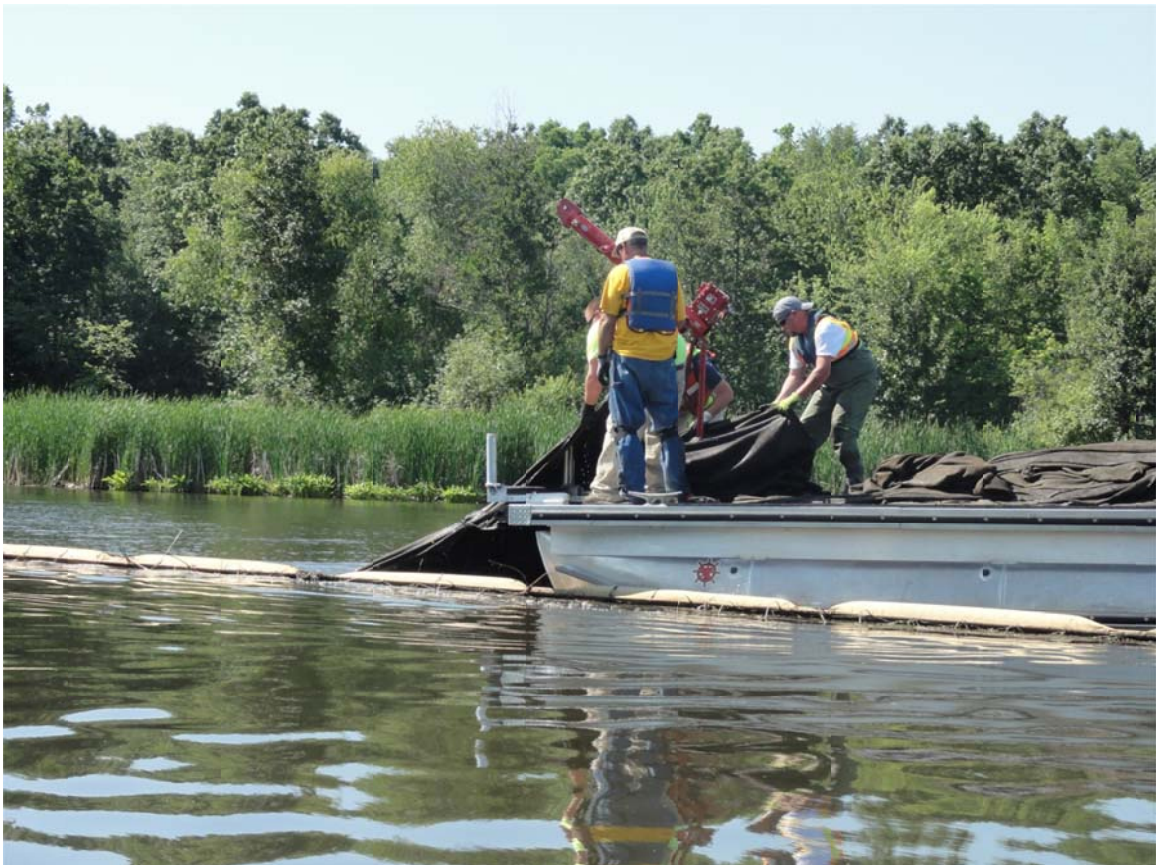
**16. Crews pulling in sediment curtain at E4.0 Control Point.**

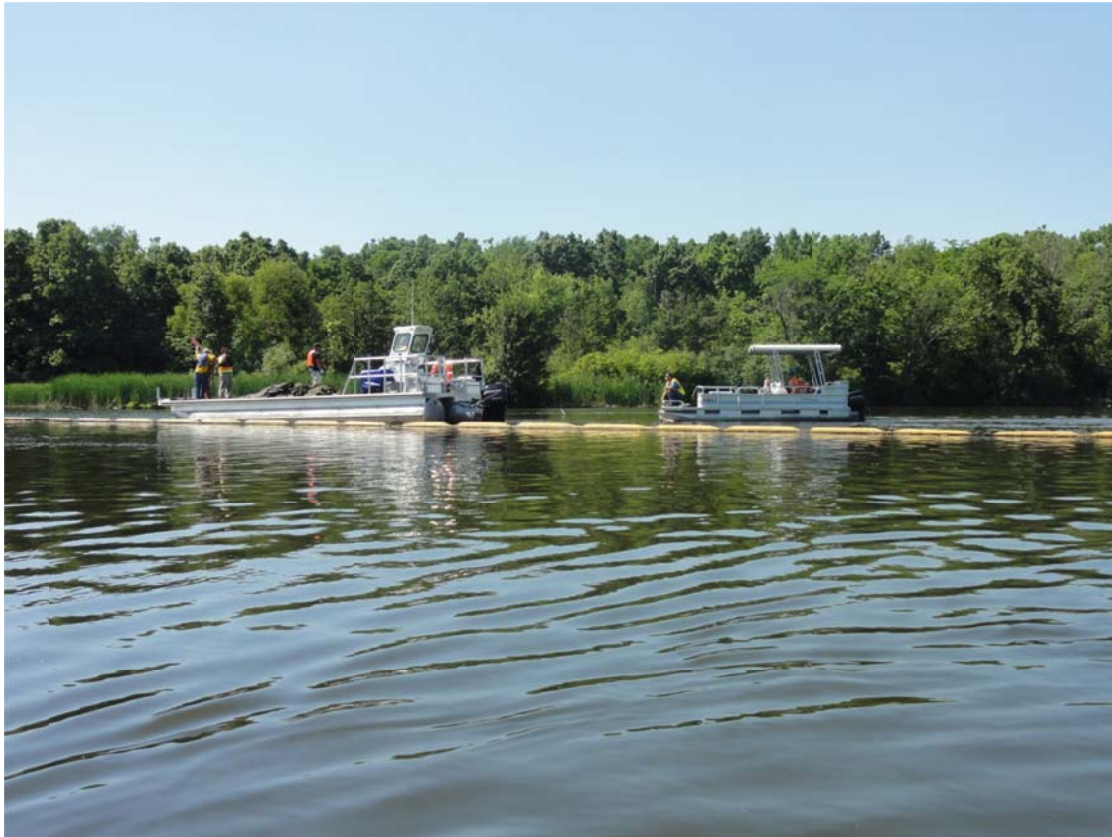
**17. Sheen sweep boat operating downstream from sediment curtain removal operations.**

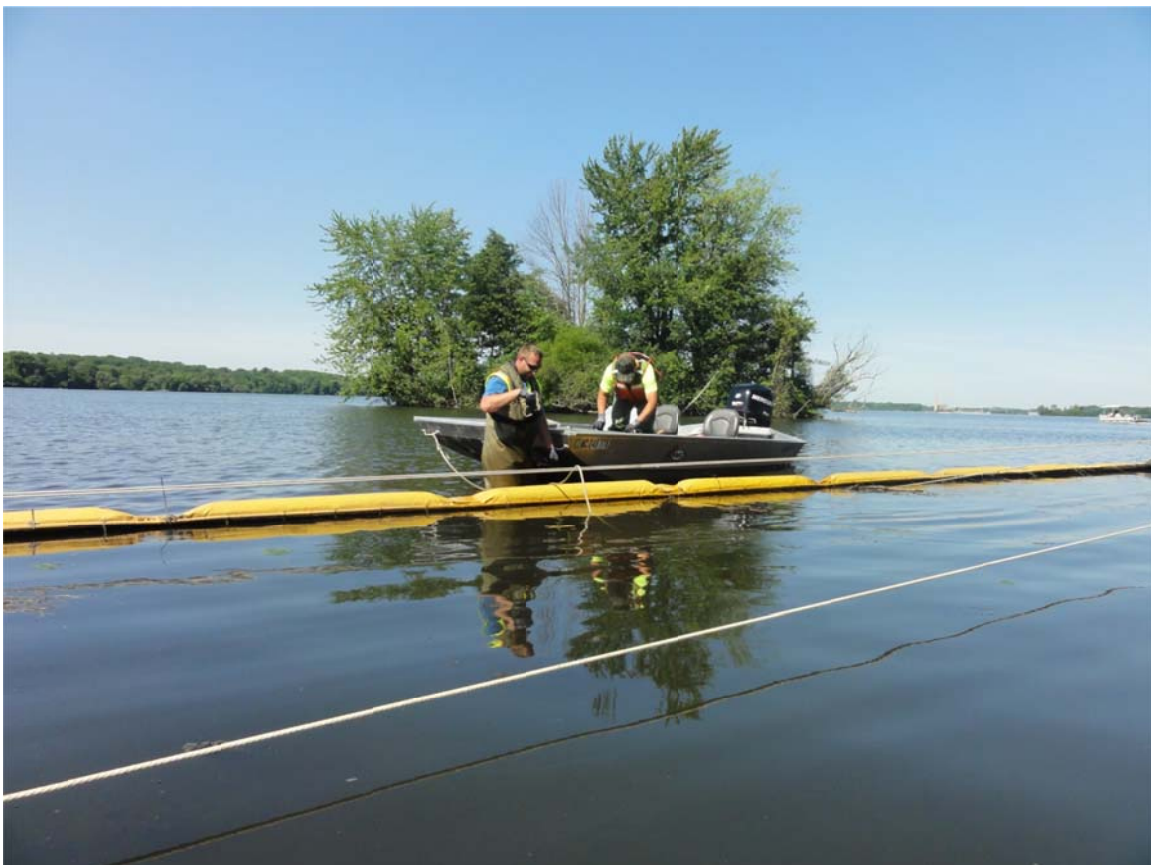
**18. Crews maintaining boom at E 4.0 Control Point.**

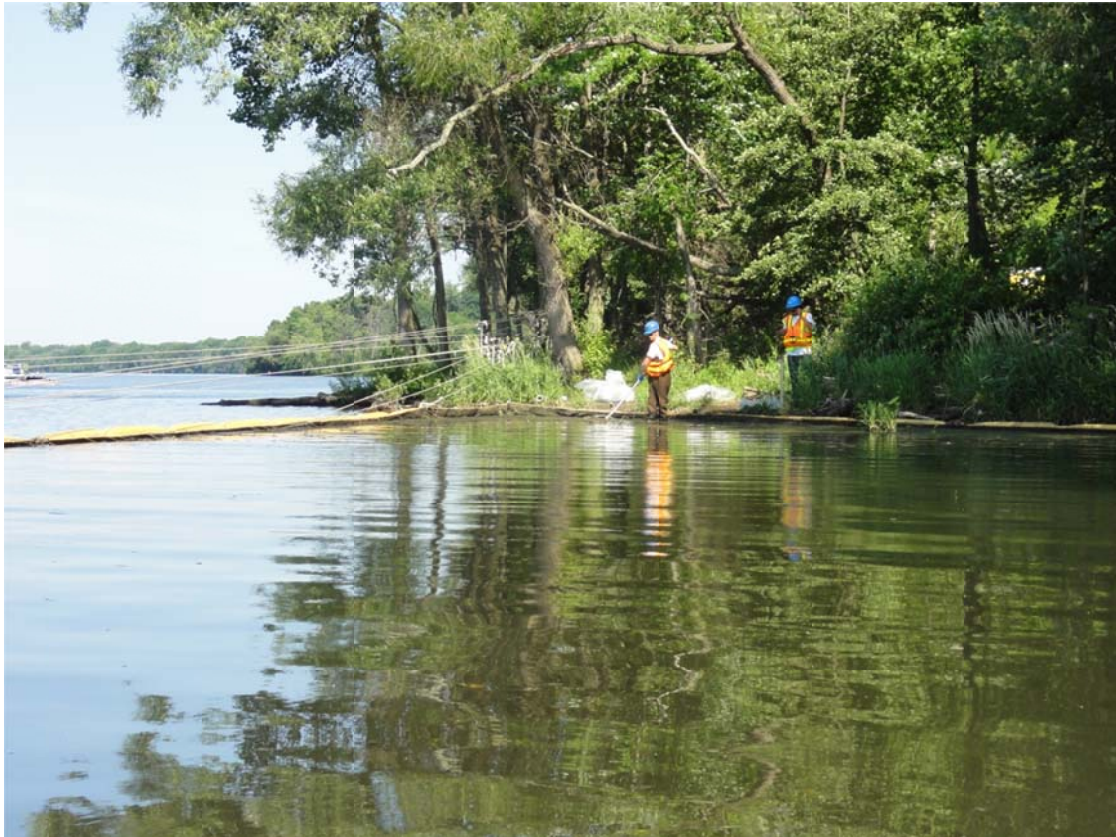
**19. Debris removal from E 4.0 Control Point.**

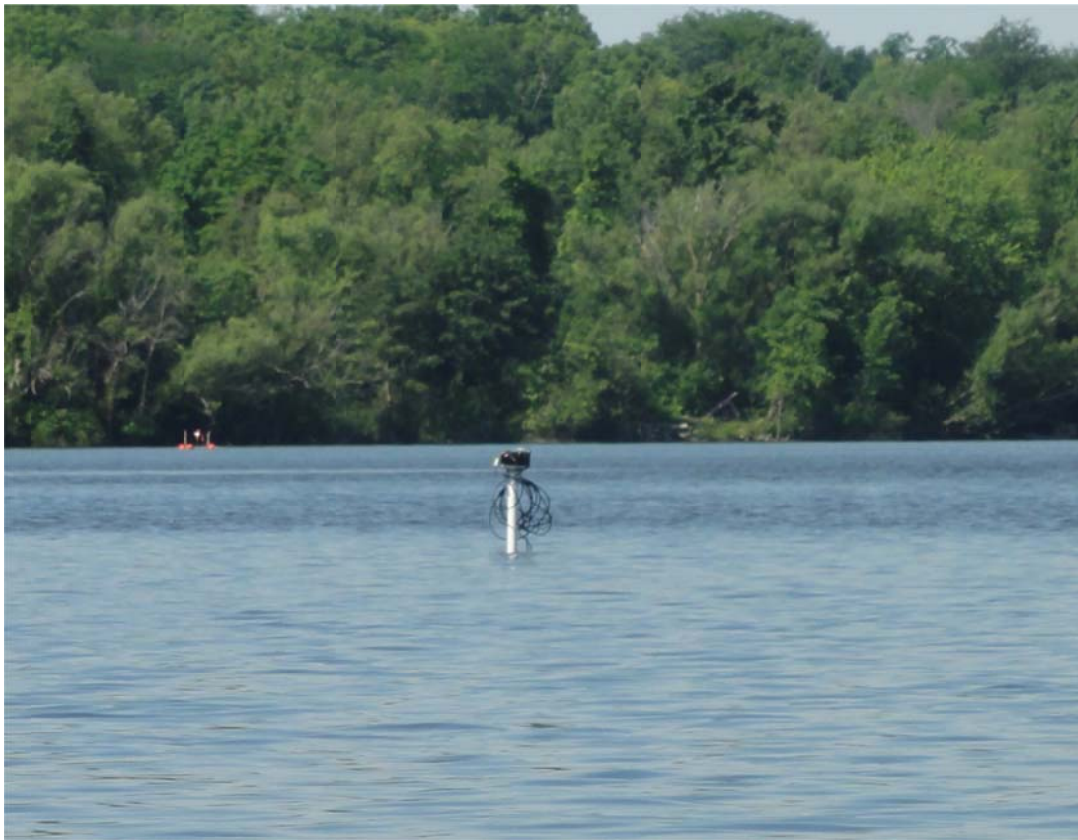
**20. Stationary water velocity meter installed just downstream of Control Point E 4.0 in the Morrow Lake fan.**
